Manhole Inspection Summary

Manhole # S63M__007MH

Location Address: **5501 O'Donnell St.**

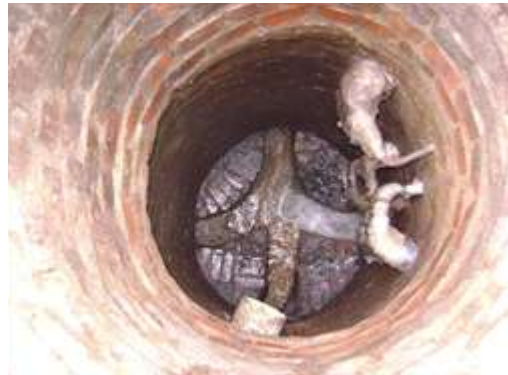
Top View

Condition: ☐ Sound ☐ Cracked ☐ Root Intrusion ☒ **Loose Brick** ☐ Deteriorated

Infiltration: ☐ None ☒ **Joint** ☐ Cracks ☒ **Mortar** ☐ Roots ☐ Wall

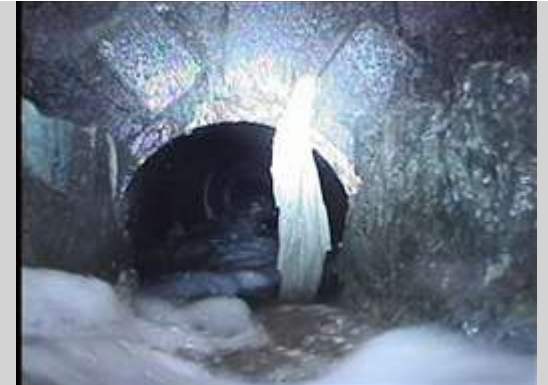
12 O'Clock Outflow

Pipe Height: **8.4** (in.) Rod and Bar (Angled)
Pipe Material: **Clay** ☐ Pipe Lined
Invert Depth: **12.50** (ft.) Flow Characteristics: **Fast**
Deposits: ☒ None ☐ Mud ☐ Sludge ☐ Debris ☐ Grease
Silt Depth: (in.) Deposits Extent:
Infiltration: **None** Pipe Seal Cond: **Sound**

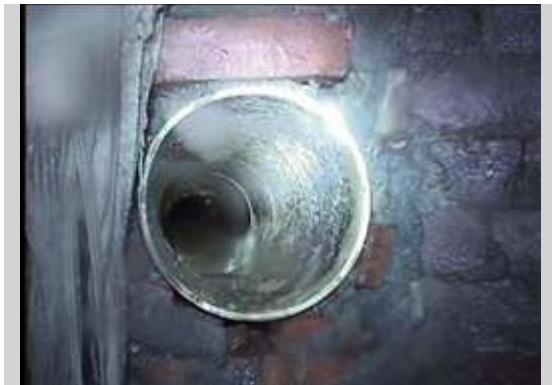
3 O'Clock Inflow

Pipe Height: **8.4** (in.) Rod and Bar (Angled)
Pipe Material: **PVC** ☐ Pipe Lined
Invert Depth: **11.00** (ft.) Flow Characteristics: **Fast**
Deposits: ☒ None ☐ Mud ☐ Sludge ☐ Debris ☐ Grease
Silt Depth: (in.) Deposits Extent:
Infiltration: **None** Pipe Seal Cond: **Sound**

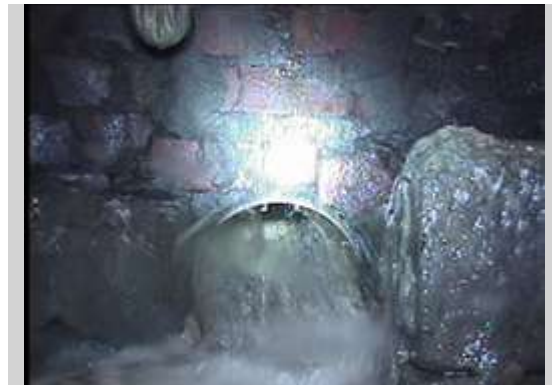
Drop In @ 3 O'Clock

Drop: **Outside** Rod and Bar
Angled: **Yes** Reading: **11.42** (ft.)
Inv Depth: **12.42** (ft.)

Drop Condition: **Open**

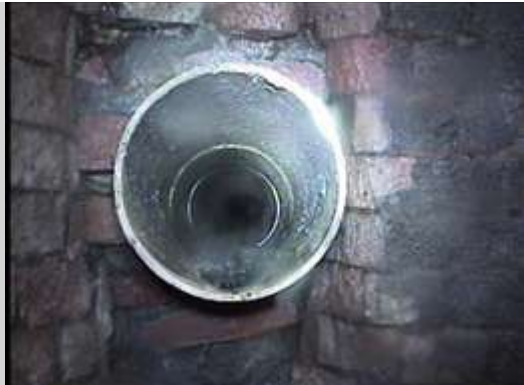
6 O'Clock Inflow

Pipe Height: **8.4** (in.) Rod and Bar (Angled)

Infiltration: **None** Pipe Seal Cond: **Sound**

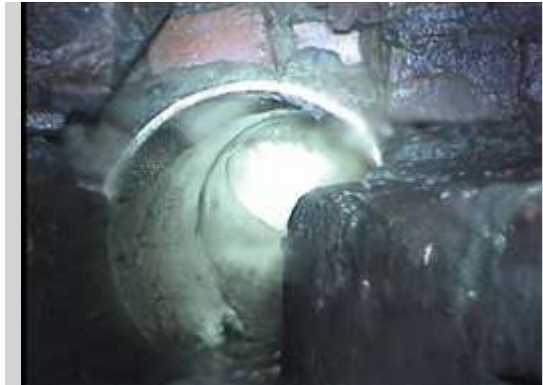
Drop In @ 6 O'Clock

Drop Condition: **Open**
